Manhole Inspection Summary

Manhole # S150O1015MH

Insp Date: **11/30/06 2:08 PM**

Location Address: **2609 BANISTER RD**

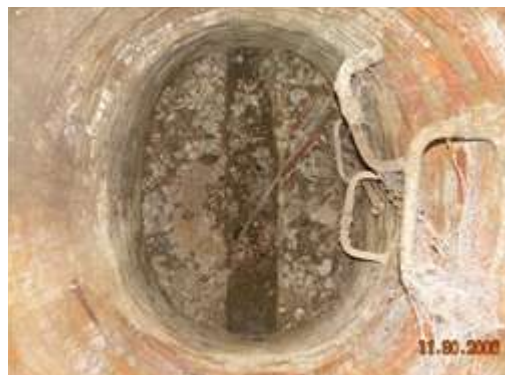
Top View

Bench and channel debris

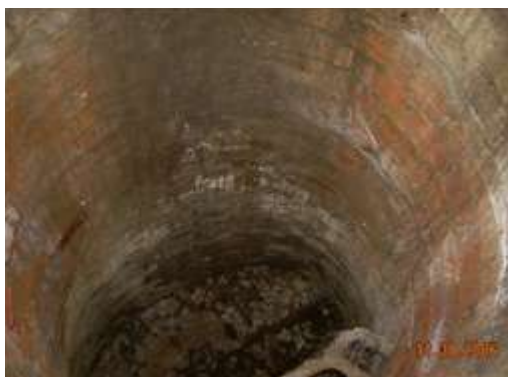
Defect

Infiltration: ☐ None ☒ **Joint** ☐ Cracks ☒ **Mortar** ☐ Roots ☐ Wall

Infiltration: ☐ None ☐ Joint ☐ Cracks ☒ **Mortar** ☐ Roots ☒ **Wall**

Adjustment and Barrel infiltration.

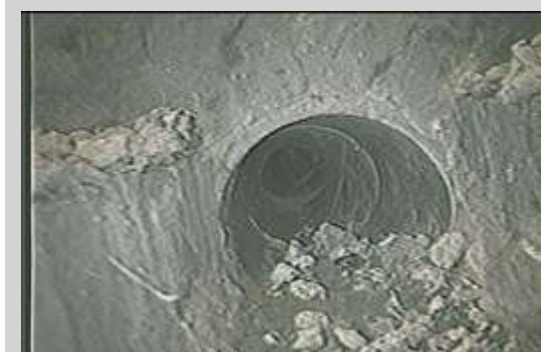
Pipe Out @ 12 O'Clock

Deposits: ☐ None ☒ **Mud** ☐ Sludge ☒ **Debris** ☐ Grease

Silt Depth: **3** (in.) Deposits Extent: **Medium**

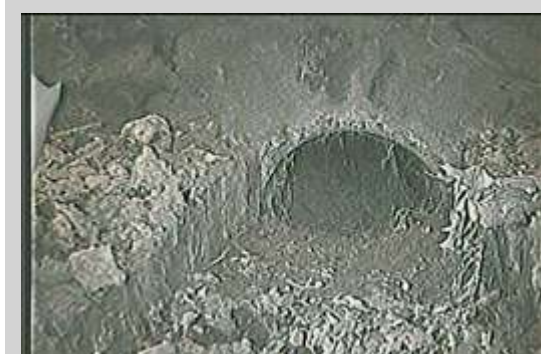
Pipe In @ 6 O'Clock

Deposits: ☐ None ☒ **Mud** ☐ Sludge ☒ **Debris** ☐ Grease

Silt Depth: **3** (in.) Deposits Extent: **Medium**

Infiltration: **Evidence** Pipe Seal Cond: **Roots**
